DEPARTMENT OF TRANSPORTATION

Contract #: 04-0120F4Cty: SF/ALA Rte: 80 PM: 13.2/13.9File #: 69.28**WELDING INSPECTION REPORT****Resident Engineer:**Siegenthaler, Peter**Address:** 333 Burma Road**City:** Oakland, CA 94607**Report No:** WIR-024812**Date Inspected:** 30-Jun-2011**Project Name:** SAS Superstructure**OSM Arrival Time:** 1500**Prime Contractor:** American Bridge/Fluor Enterprises, a JV**OSM Departure Time:** 300**Contractor:** Zhenhua Port Machinery Company, Ltd (ZPMC), Changxing Island **Location:** Sanghai, China**CWI Name:** See Below**CWI Present:** Yes No**Inspected CWI report:** Yes No N/A**Rod Oven in Use:** Yes No N/A**Electrode to specification:** Yes No N/A**Weld Procedures Followed:** Yes No N/A**Qualified Welders:** Yes No N/A**Verified Joint Fit-up:** Yes No N/A**Approved Drawings:** Yes No N/A**Approved WPS:** Yes No N/A**Delayed / Cancelled:** Yes No N/A**Bridge No:** 34-0006**Component:** OBG**Summary of Items Observed:**

WELDING INSPECTION REPORT

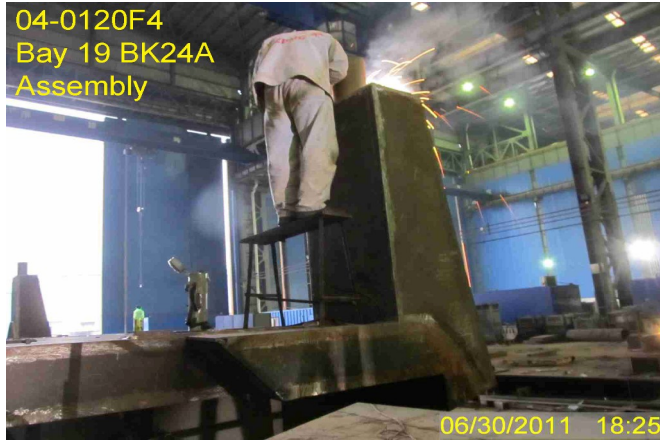
This QA inspector performed a random observation for the OBG. During the observation performed it was noted ZPMC was in process of grinding interior welds and surfaces on bike path assembly BK23A and observed SMAW welding on Bike path assembly BK24A. ABF inspector Peng Wen Jun was present at this time of this observation and informed this QA inspector of the work that is in process. It was stated that ZPMC had 1 welder and identified the welder by ZPMC welder identification number appointed to then by ZPMC. This QA inspector verified this information for the following location;

Weld- BK24A11-001-009, 031, 021, 022

WPS-B-P-2112

Welder- 259906

2F/SMAW

The following digital picture illustrates welding on BK24A assembly.
